SAFETY CAMPAIGN

2017

For a Maritime Pilot, embarking and disembarking a ship is an extremely hazardous undertaking. The method of operation has changed very little over many generations. However, consistently a remarkably large percentage of vessels still fail to comply with Solas Regulation V/23 and IMO Resolution A. 1045(27) which sets out mandatory compliance standards for those arrangements.

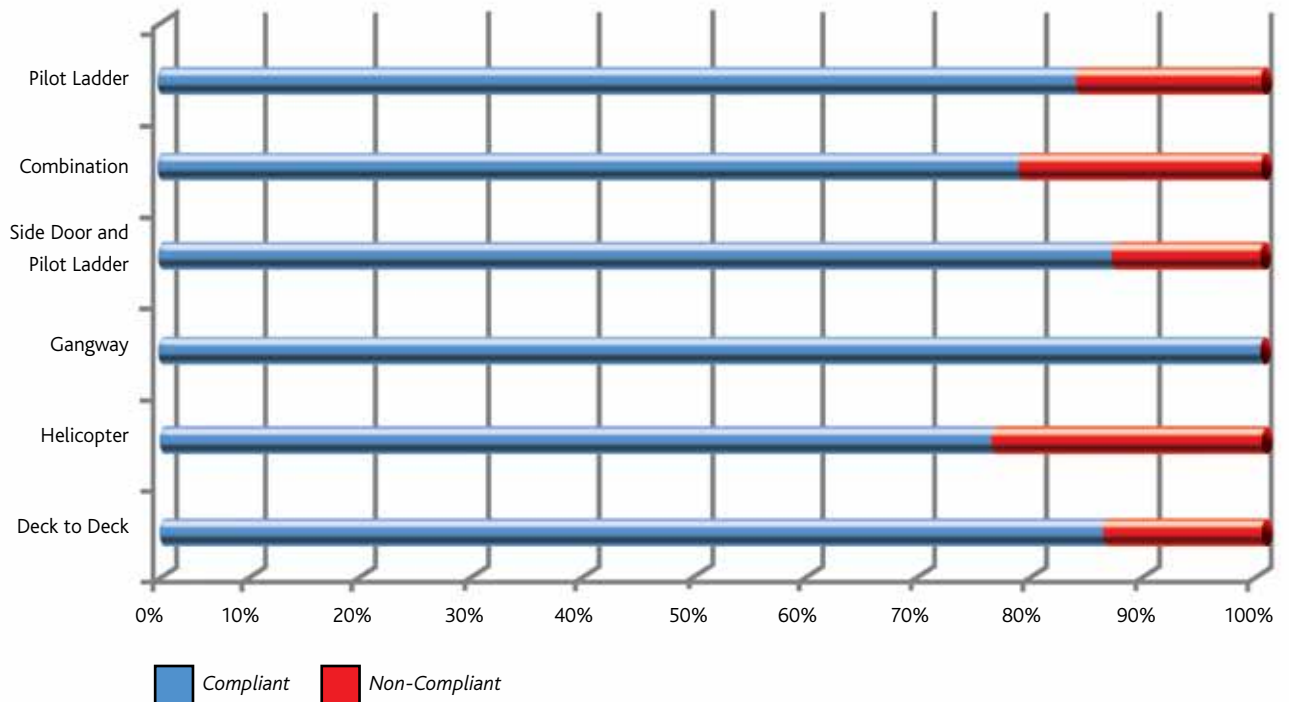
COMPLIANCE BY MEANS OF TRANSFER

The following chart shows a breakdown of all returns by means of transfer.

MEANS OF TRANSFER	TOTAL NUMBER	COMPLIANT	NON COMPLIANT	NON COMPLIANT AS %
Pilot Ladder	1897	1601	296	15.6
Combination	625	496	129	20.64
Side Door and Pilot Ladder	275	241	34	12.36
Gangway	44	44	0	0
Helicopter	26	20	6	23.08
Deck to Deck	114	99	15	13.16
TOTAL	2981	2501	480
